Perkins Beach Groin Rehabilitation Edgewater Park

Sean E. McDermott, P.E. Chief Planning and Design Officer

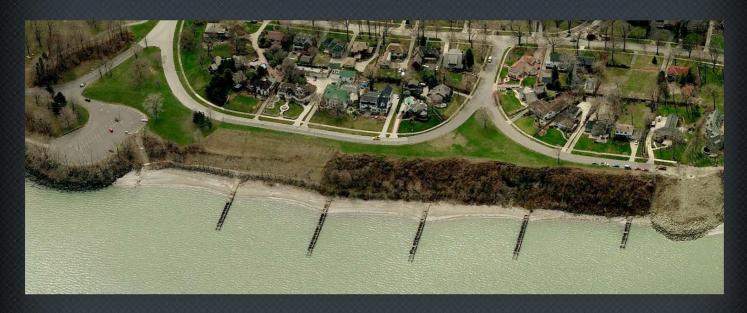
Beach tapers east to west Arcs between groins

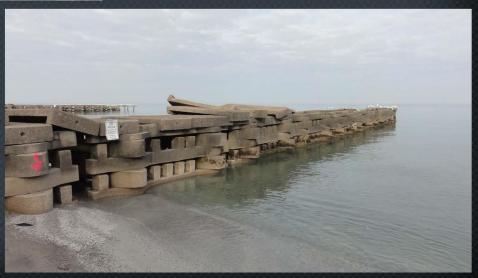
Rubble west end

Empty piers

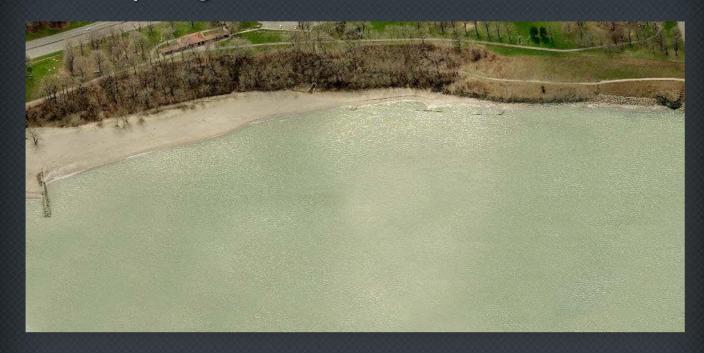
Beach tapers east to west

Salients develop behind concrete modules
