## Beecher's Brook Restoration and Chagrin River Restoration at Jackson Field

North Chagrin Reservation  
and South Chagrin  
Reservation

November 13, 2019

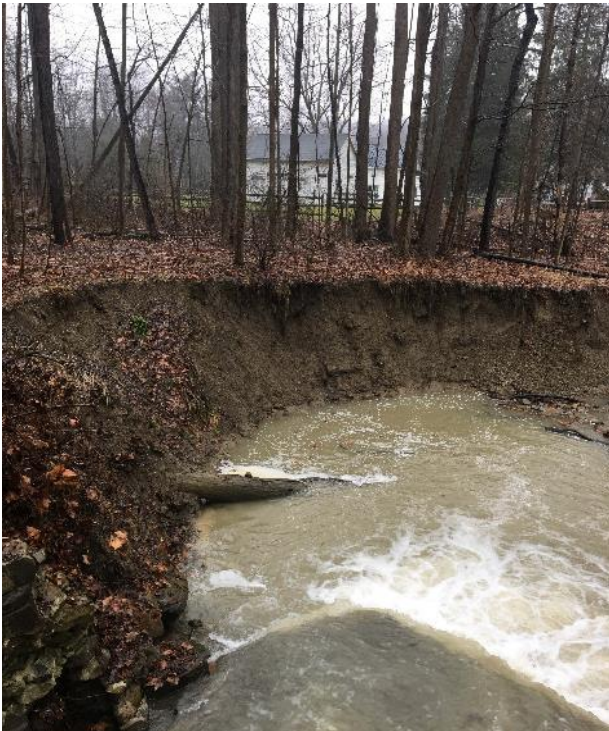
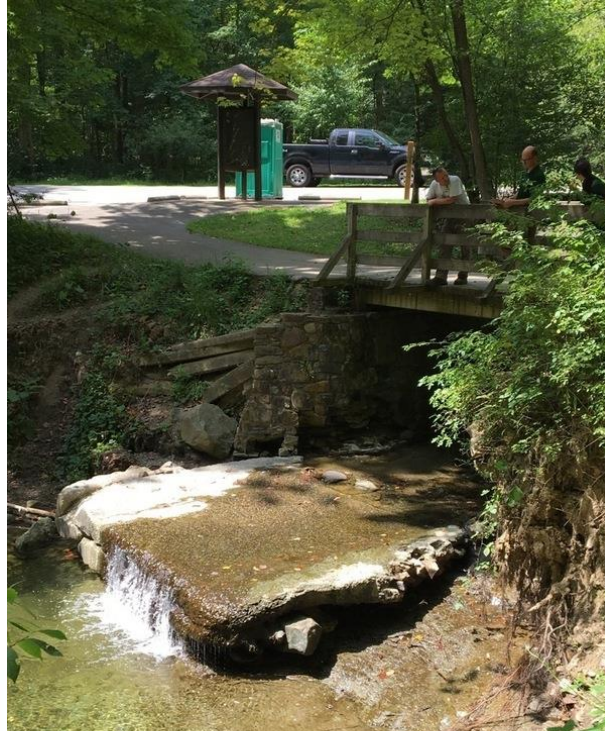
**Beecher's Brook at Wilson Mills trailhead**

- Severe streambank erosion
- Lack of fish passage
- Excessive sediment loss

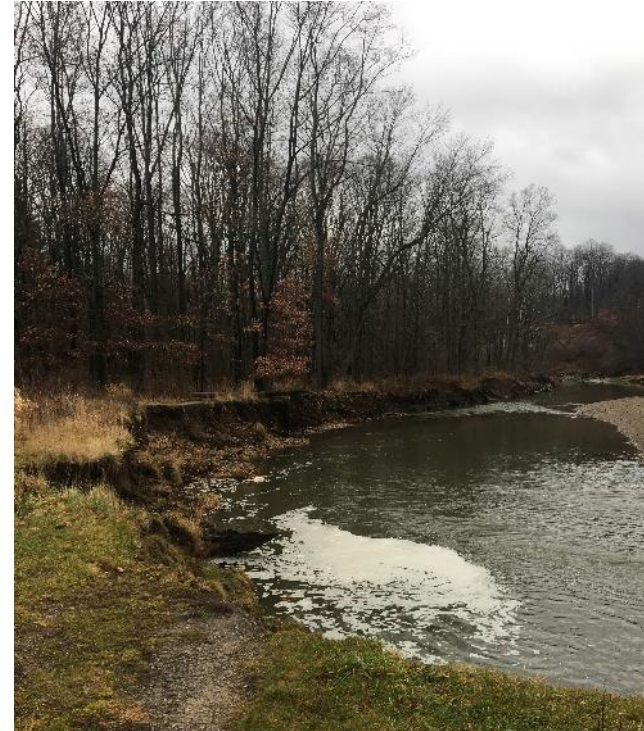
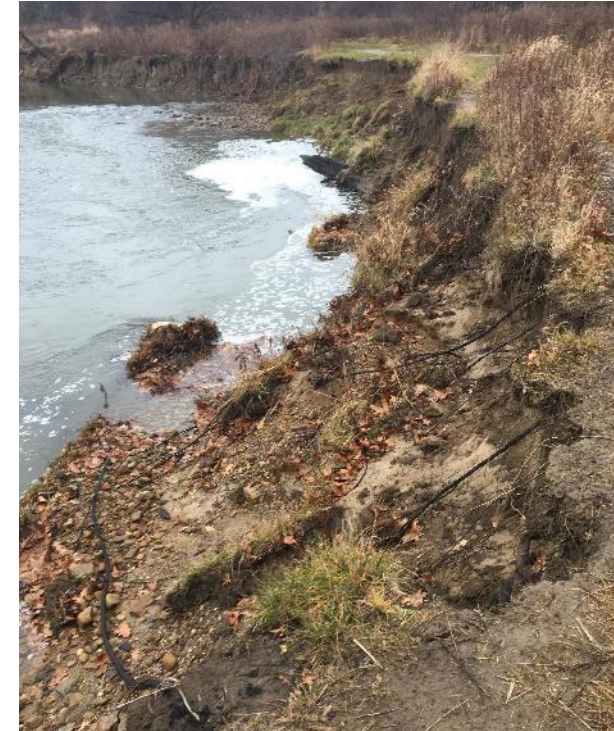
**Chagrin River at Jackson Field**

- Severe streambank erosion
- Lack of floodplain connection
- Excessive sediment loss

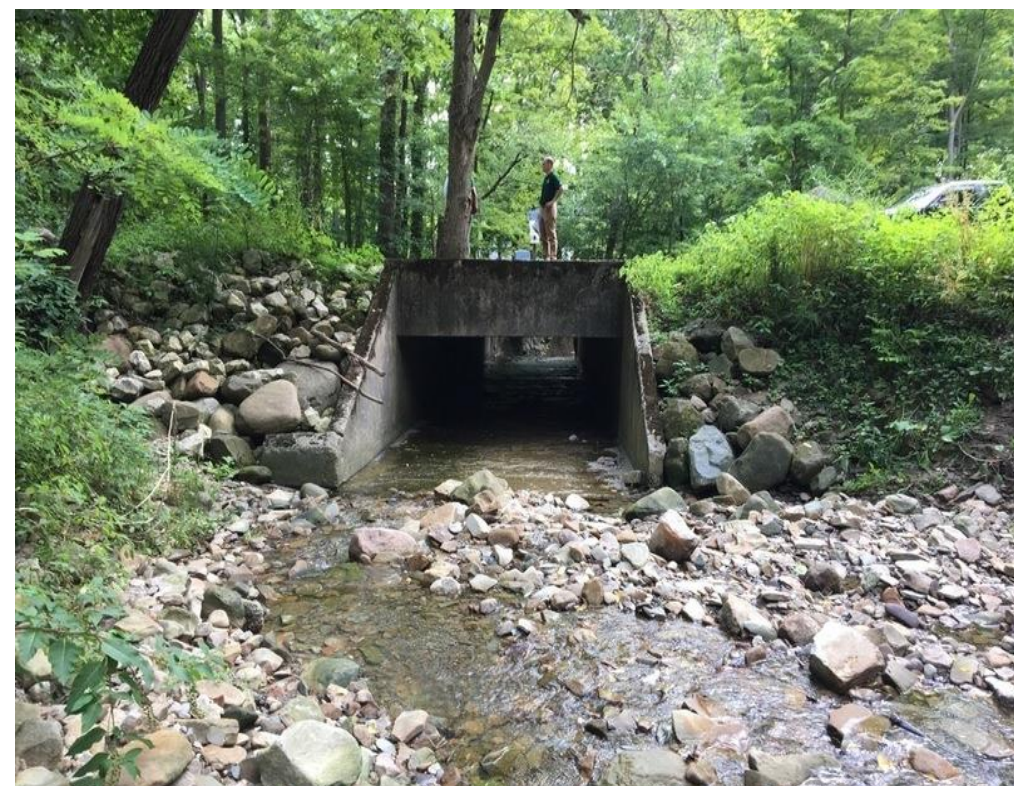
**Undersized culvert – Beecher's Brook**

Replace existing 12' wide Box  
culvert with appropriately sized  
box culvert

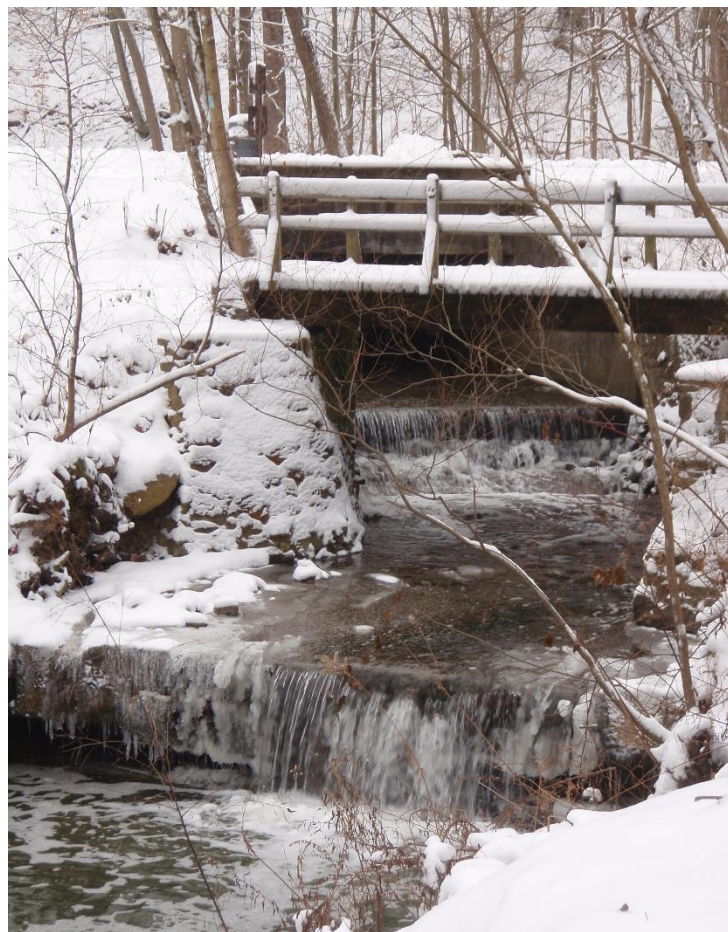
**Fish Migration Barrier – Beecher's Brook**

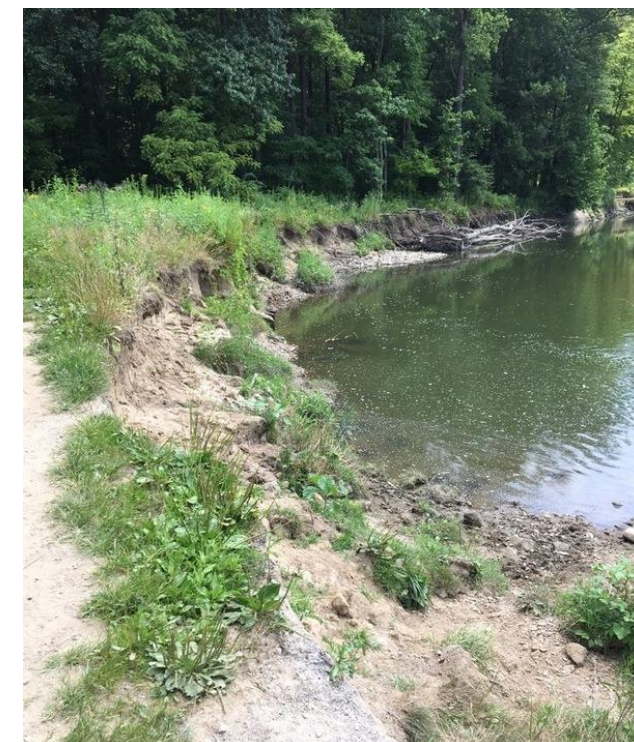
**Eroding streambank on Chagrin River**

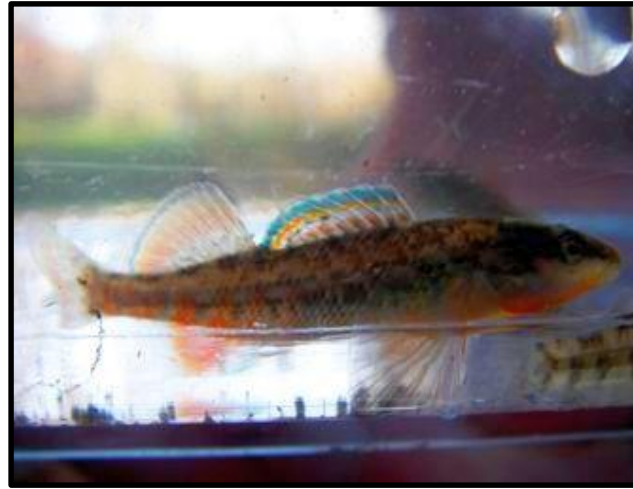
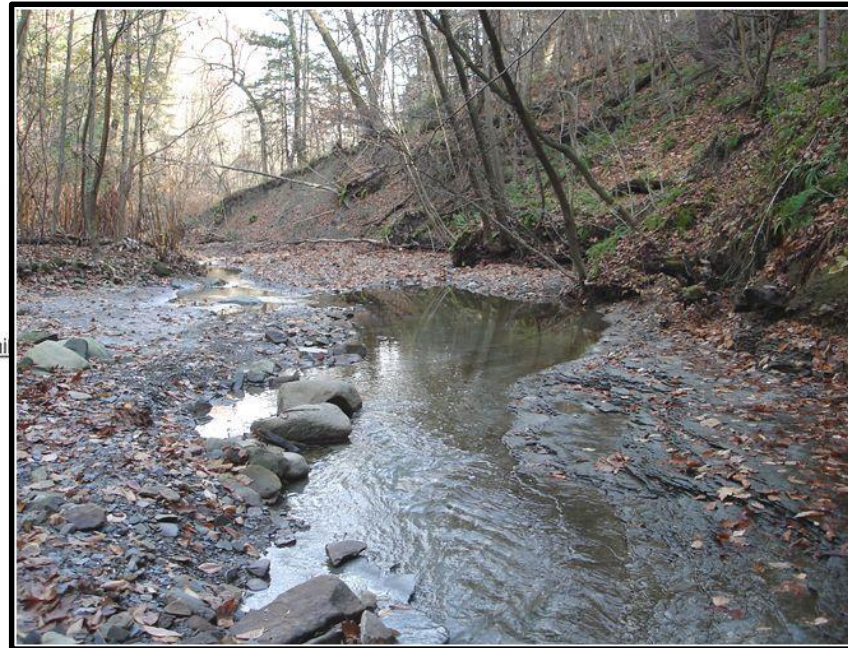
**Ohio EPA** Qualitative Habitat Evaluation Index and Use Assessment Field Sheet **QHEI Score: 64**

Stream & Location: Beecher's Brook (NC-01) RM: 0-09 Date: 8/23/17

% POOL: 20 % GLIDE: 10 % RIFFLE: 50 % RUN: 20

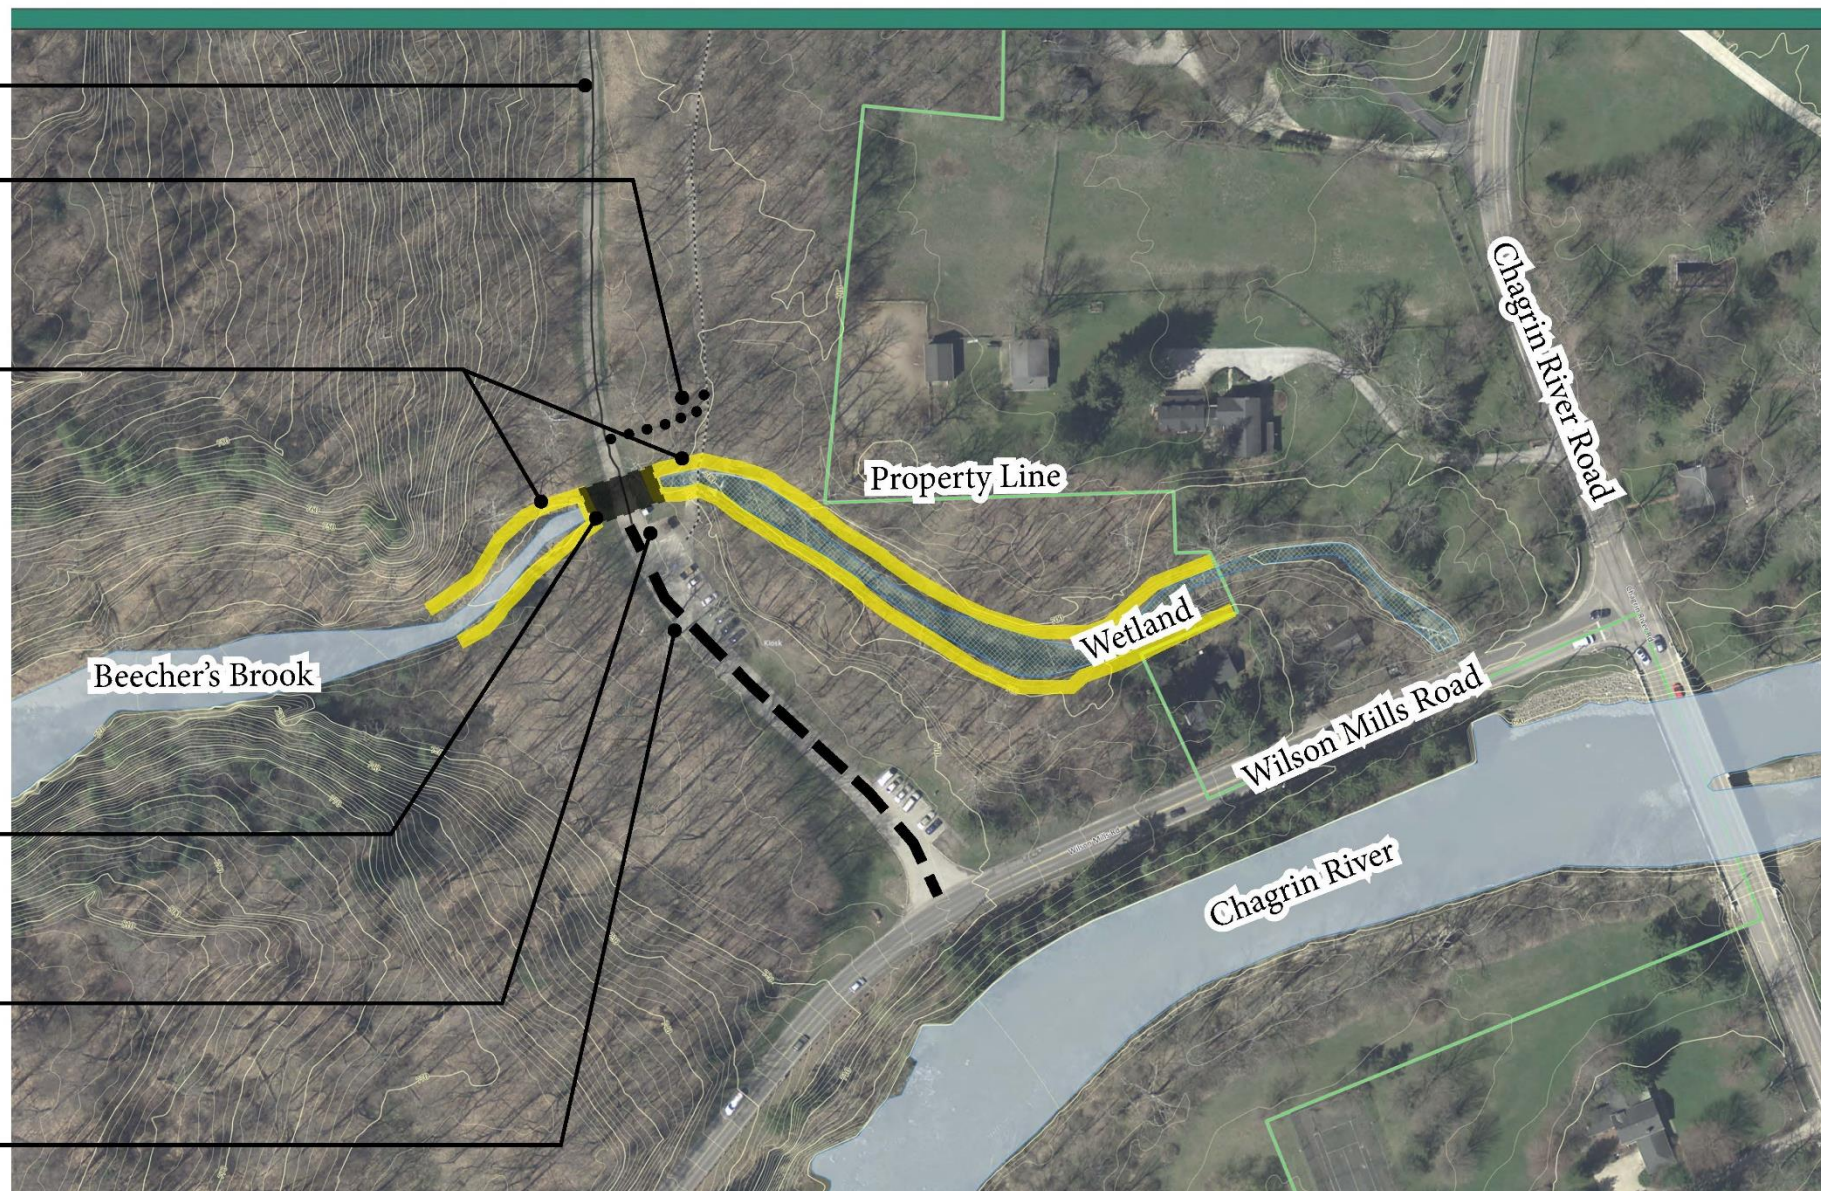
# Solutions Proposed – Beecher's Brook

Existing All-Purpose Trail

Re-align Buckeye Trail  
(Future by Cleveland Metroparks)

Stabilize +/- 350 lineal feet of  
eroding streambank,  
remove bridge across Beecher's  
Brook and improve fish habitat

Improve Trailhead  
(Future by Cleveland Metroparks)

Existing site access and parking lot

- Restore 350 In. ft. of stream and its banks
- Remove fish barrier and enhance fish migration
- Install 2 ac. of riparian plantings and buffer enhancement

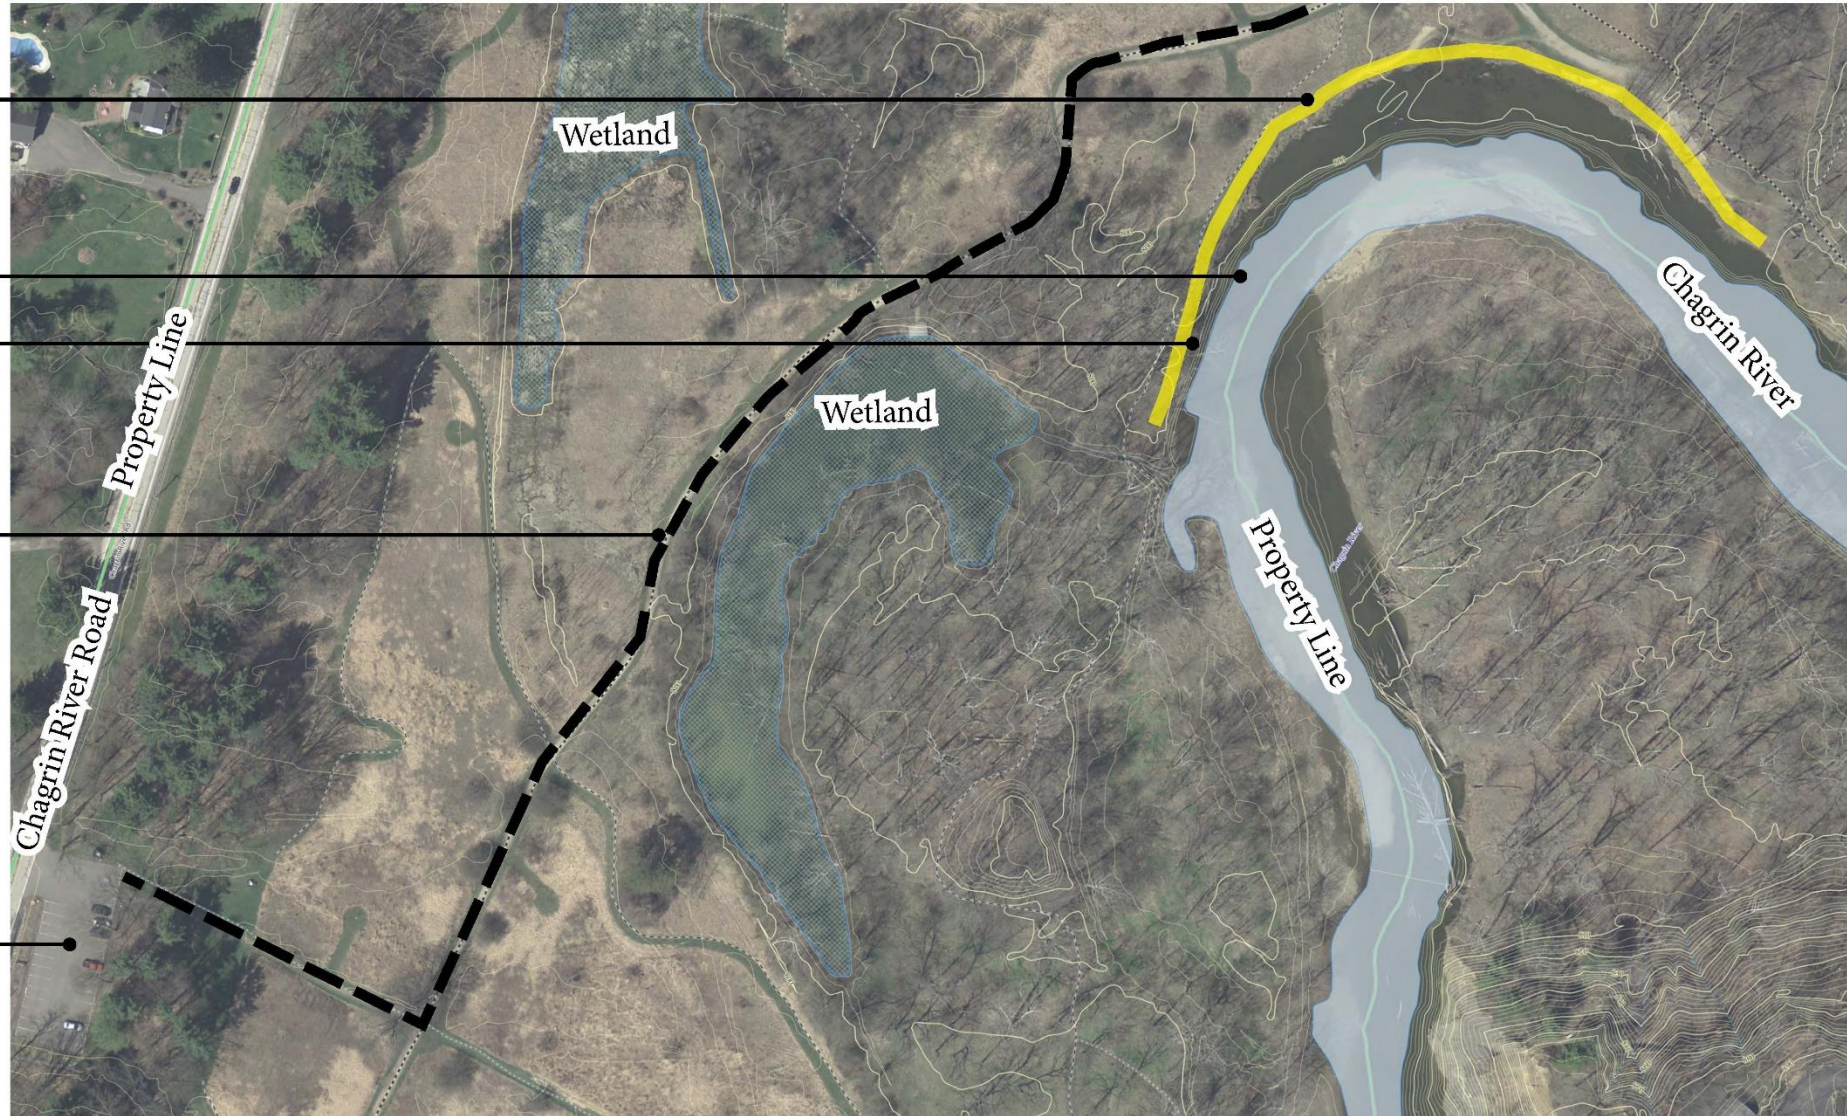
# Solutions Proposed – Chagrin River at Jackson Field

Restore +/- 500 lineal feet of streambank

Improve fish habitat

Restore floodplain connectivity and revegetate

Existing Bridal Trail/Site Access

Existing Parking Lot

- Stabilize 500 In. ft. of streambank
- Floodplain connection
- Install 0.25 ac. of riparian plantings and buffer enhancement
